AIRCRAFT RESEARCH AND DEVELOPMENT UNIT

TECHNICAL INVESTIGATION NO 760

EVALUATION OF INSTALLATION OF LIGHTWEIGHT DOPPLER NAVIGATION SYSTEM (LDNS) IN IROQUOIS UH-1H AIRCRAFT

NOVEMBER 1983

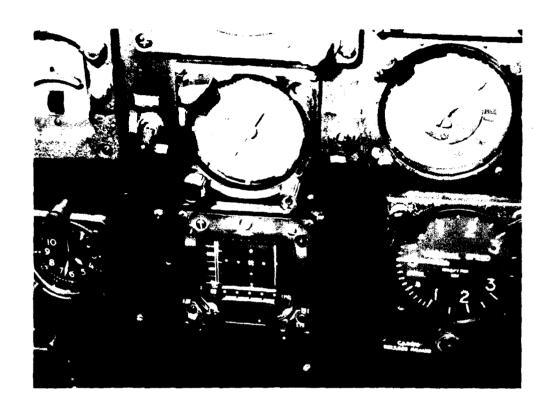
FIGURE 5.3 - VIEW OF SHIU FROM PILOT'S DESIGN EYE POINT

5.1.2.2 Steering and Hover Indicator Unit (SHIU). The SHIU was positioned under the pilot's primary flight instruments in lieu of the VHF-FM homing indicator, and was intended to be used by the pilot only. The SHIU controls were well within the functional reach of the pilot; however, the angle between the pilot's line-of-sight to the instrument and the plane of the instrument face was only approximately 50°. This led to significant parallax errors. A view of the SHIU from the pilot's DEP (approximately) is shown in Figure 5.3. During tactical flying, the pilot was required to regularly consult the instrument for steering and distance-to-go information. The instrument was positioned well away from the scan pattern used by the pilot for good look-out (obstacle/collision avoidance, identification of features, landing pads, possible threats). As a consequence, look-out by the pilot was slightly degraded. This, in combination with the parallax errors, made the position of the SHIU unsatisfactory. The instrument should be repositioned to reduce parallax errors and bring the instrument closer to the visual scan used by the pilot for tactical flying. Revised positioning will be assessed and reported under Reference N. The applicable requirement of AIR STD 10/30H and 10/38C were met (see Annex C, Serials 3 to 5).
